TDA2x SoC for Advanced Driver Assistance Systems (ADAS) Silicon Revision 2.0, 1.1

Errata

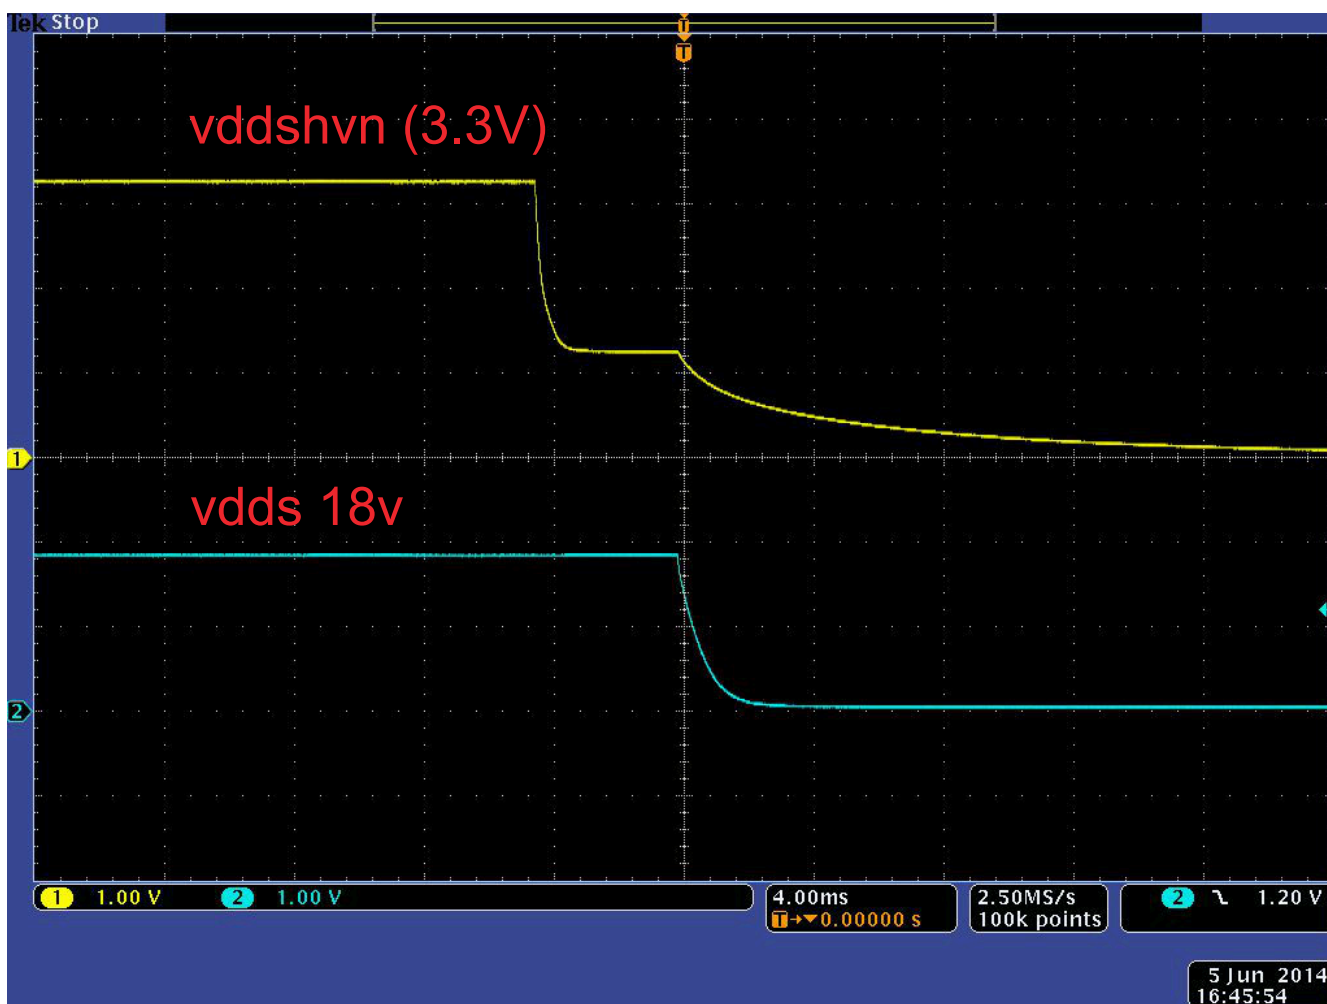
Figure 4-1. PAB_RevA

The Data Manual allows the vddshvn rail (in either 3.3V or 1.8V mode) to power down at the same time or before the vdds18v rail. When the vddshvn rail is powered down before the vdds18v rail, the vddshvn rail stays at Plateau Level (<1.5V) until the vdds18v rail is disabled, as shown in the waveform below.

A subset of the SOC's LVCMOS IOs (refer to DM for details) have a pull-up resistor that is active by default, including during reset and power-down. The SOC's IOs that have internal or external pull-ups will stay at Plateau Level (<1.5V) during the power-down. If other ICs on the board that are interfaced to the SOC's LVCMOS signals use a separate supply then it's possible that the other IC's signals can be pulled to the Plateau Level while its power supply is off.

The root cause of the plateau is related to the LVCMOS IO buffer Dual Voltage detection circuitry. The LVCMOS Dual Voltage IO includes voltage comparator circuitry to determine

In general, TI recommends using the same supply source for connected components. E.g., a single LDO should drive vddshvn and the related 3.3V external components.

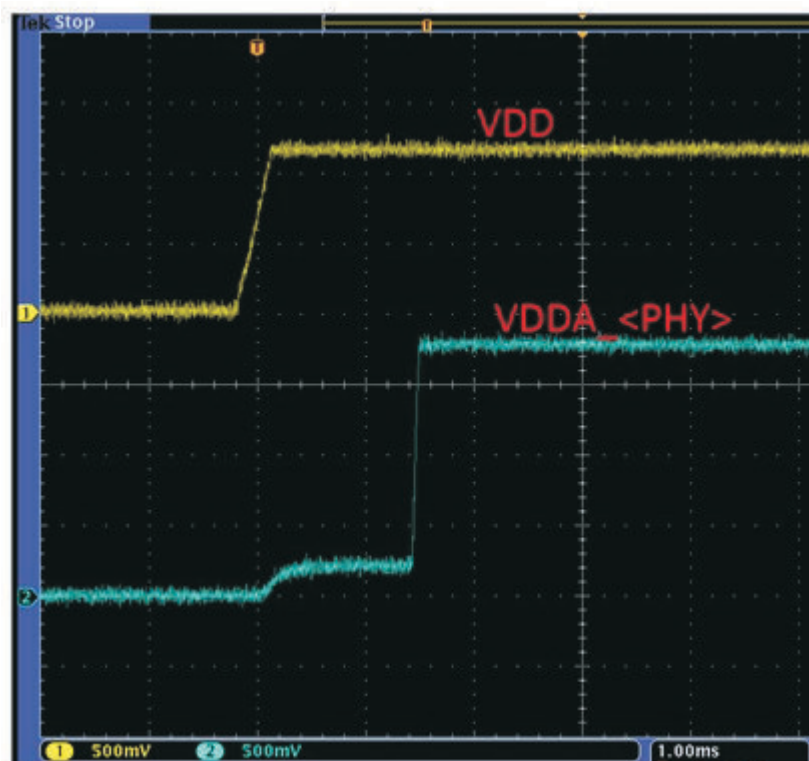
Figure 4-2. Leakage Voltage

The device-specific Data Manual requires Core AVS rail (VDD) to power up before the 1.8 V high speed analog PHY domain(s). When this sequence is followed, the high speed analog PHY domain will have a small step-up to a voltage plateau (< 0.5 V) that aligns to the beginning of the VDD ramp-up, and is maintained until the ramp-up of high speed analog PHY rail, as shown in [Figure 4-2](#). Note the leakage value will differ from system to system, but will be less than 500 mV. The leakage voltage in the provided capture is approximately 250 mV.

A similar condition exists during supply power down sequence. The high speed analog PHY domain(s) are required to be powered down prior to Core AVS rail (VDD), and may cause a small plateau to exist until Core AVS rail (VDD) is ramped down.

The root cause of the voltage plateau during power-up/down sequencing is related to the parasitic diodes in logic blocks which have multiple power sources. This leakage path is not a reliability concern for this device.
